**Flood Control Project Maintenance
Levee Inspections**
LMA District Cover Sheet
Spring 2017 Levee Inspection Results

Lake County Watershed Protection District

Spring 2017 Levee Inspection Results

Waterway			Bank	Unit Miles
Unit No. 01 Middle Creek			Left	3.35
	Spring (March - May)	Summer (June - August)	(September - November) Fall	Winter (December - February)
Unit Maintenance Rating (Fall Only)				
Date of Inspection	4/4/2017 - 4/4/2017			
DWR Inspector	Bob Duffey			
Accompanied By	Will Evans Lake County

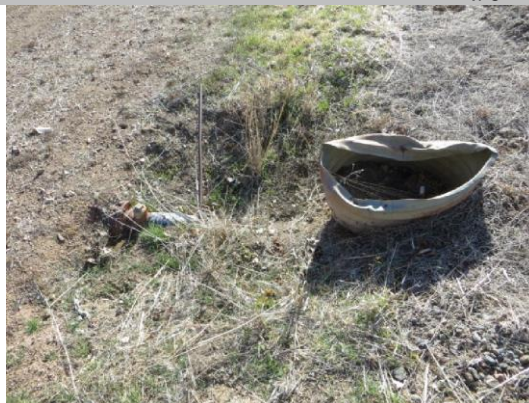
Photo 1 of 3 : UCIP_SP_2017_26943_49782.jpg

Comment Code					
Inspector Comment					
FS_ID:26943 DS_ID:21193 EP_NO: 5237 Repair Type: Non-Urgent Crossing Status: Found UCIP Comments: Pipe appears abandoned and should be done so properly. FIELD_STRUCT_DESC: *ABANDONED* 6-inch steel pipe possibly sleeved through an 8-inch steel pipe, 3.0-feet below the crown. Siphon breaker in 24-inch CMP riser on the landward slope. Reinforced concrete cutoff wall at center of levee. Butterfly valve on the waterward side at pump on concrete base on the waterward bank, installed under Permit No. 5237 (1971). Pole on the waterward berm, with overhead power line supplying electricity to pump. Originally included in the 1961 O+M manual. FS Date: 1/9/2014

Pipe and siphon breaker visible on LS slope.

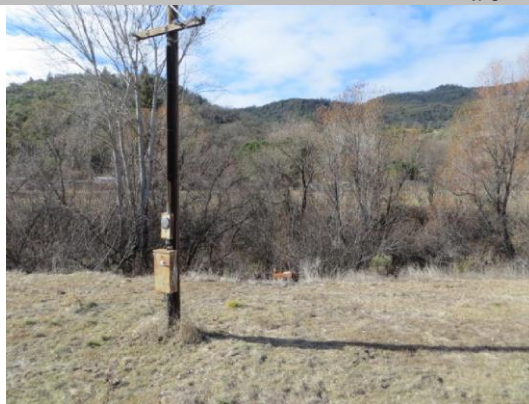
Photo 2 of 3 : UCIP_SP_2017_26943_49781.jpg

Power pole, meter, and pump visible on WS berm.

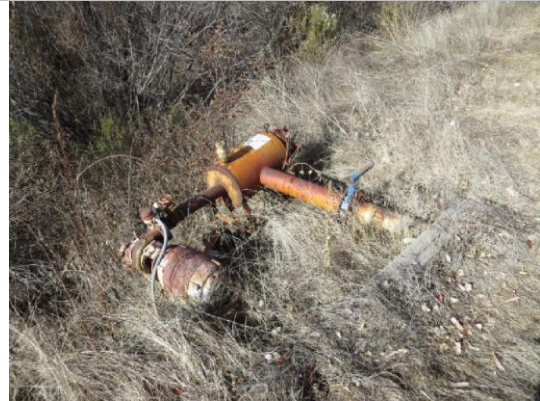
Photo 3 of 3 : UCIP_SP_2017_26943_49780.jpg

Pump and butterfly valve on WS berm.

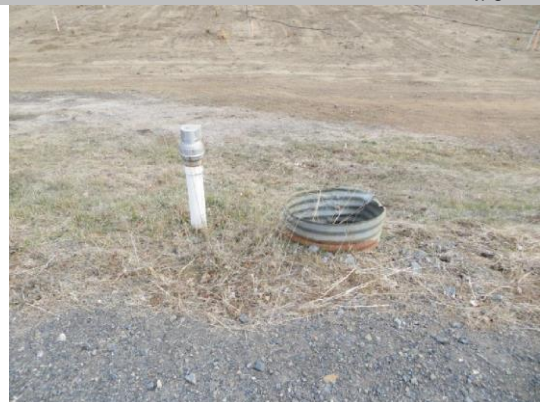
Photo 1 of 3 : UCIP_SP_2017_26946_49789.jpg

LM Start	0.84	Rating **	M	Issue No.	536
LM End	0.84	Issue Type +	En	Location *	LS
Category	Supplemental			GPS Latitude/Longitude	
				Start	End
Item	DWR UCIP Field Study			39.179534 °	39.179534 °
				-122.912512 °	-122.912512 °
DWR ID					
Comment Code					
Inspector Comment					
FS_ID:26946 DS_ID:21196 EP_NO: N/A Repair Type: Non-Urgent Crossing Status: Found UCIP Comments: Pump and pipe appear abandoned and should be done so properly. FIELD_STRUCT_DESC: *ABANDONED* 8-inch steel irrigation pipe through the levee, 3.0 feet below the crown. Siphon breaker in 24-inch CMP riser on landward slope. Pump on the waterward bank with a butterfly valve. Service pole on the waterward berm. (USACE-1961). This entry matches the Drainage or Irrigation Structure referenced in O&M manual (HLM 0.83). FS Date: 1/9/2014

Siphon breaker in 24-inch cmp riser with vent on LS shoulder.

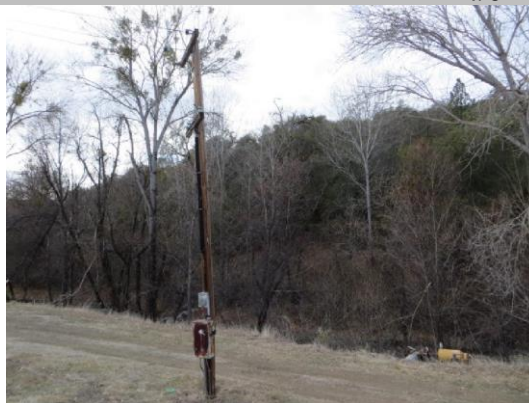
Photo 2 of 3 : UCIP_SP_2017_26946_49788.jpg

Pump, pole, and meter on WS berm.

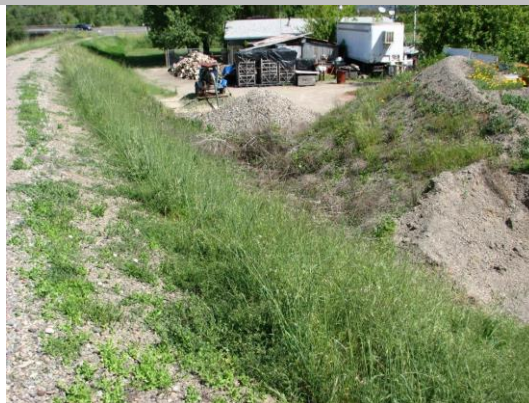
Photo 1 of 1 : SP_2017_NA0009_3_26_20170315_00016.jpg

5/2/2016: Remove large gravel piles from L/S toe.

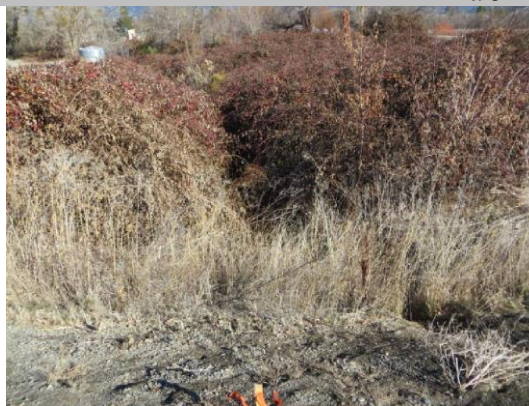
Photo 1 of 3 : UCIP_SP_2017_26987_49853.jpg

LM Start	2.26	Rating **	A/W	Issue No.	537
LM End	2.26	Issue Type +	Ma	Location *	LS
Category	Supplemental			GPS Latitude/Longitude	
				Start	End
Item	DWR UCIP LMA Responsibility			39.160327°	39.160327°
				-122.913998°	-122.913998°
DWR ID					
Comment Code					
Inspector Comment					
FS_ID:26987 DS_ID:21240 EP_NO: N/A Repair Type: No Action Needed Crossing Status: Found UCIP Comments: FIELD_STRUCT_DESC: 2 of 2: 36-inch CM drainpipe through the levee, 9.0 feet below the crown. Flap gate on the waterward end. Concrete headwalls on both ends. Originally listed in 1961 O+M manual. Pipes retained through levee under ABO No. 11460 (1975). FS Date: 1/14/2014

Pipe and Concrete headwall visible on LS toe.

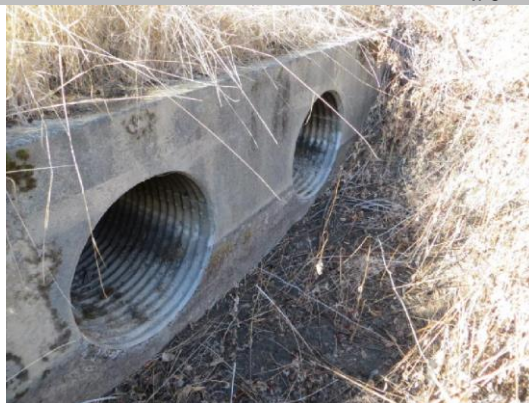
Photo 2 of 3 : UCIP_SP_2017_26987_49852.jpg

Pipe and Concrete headwall visible on LS toe.

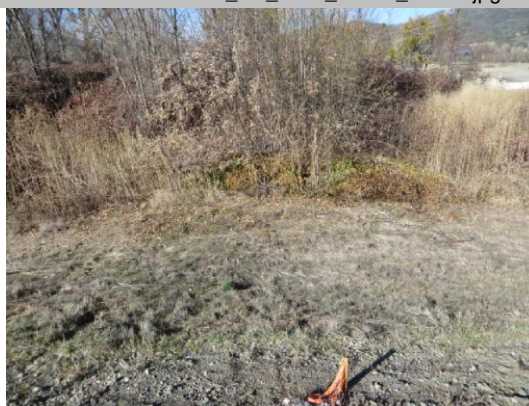
Photo 1 of 3 : UCIP_SP_2017_27004_49862.jpg

LM Start	2.35	Rating **	M	Issue No.	539
LM End	2.35	Issue Type +	Ma	Location *	WS
Category	Supplemental			GPS Latitude/Longitude	
				Start	End
Item	DWR UCIP LMA Responsibility			39.161002 °	39.161002 °
				-122.912843 °	-122.912843 °
DWR ID					
Comment Code					
Inspector Comment					
FS_ID:27004 DS_ID:21199 EP_NO: 11460 Repair Type: Non-Urgent Crossing Status: Found UCIP Comments: Heavy vegetation on LS at inlet should be removed. FIELD_STRUCT_DESC: 42-inch CM drainpipe through the levee, 10.0 feet below the crown. Flap gate on waterward end. Concrete headwall on both ends. Originally included in 1961 O+M manual. Pipe retained under ABO No. 11460 (1975). FS Date: 1/14/2014

Heavy vegetation at inlet on LS toe.

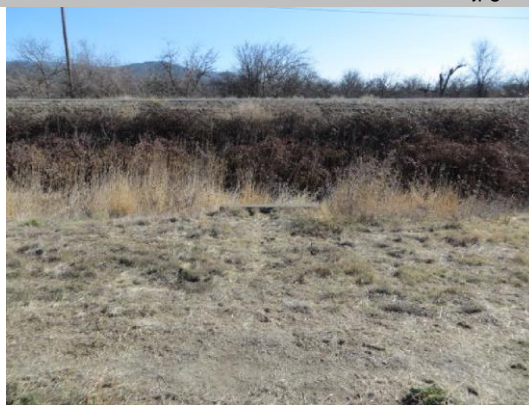
Photo 2 of 3 : UCIP_SP_2017_27004_49861.jpg

Concrete U-shaped headwall on WS berm.

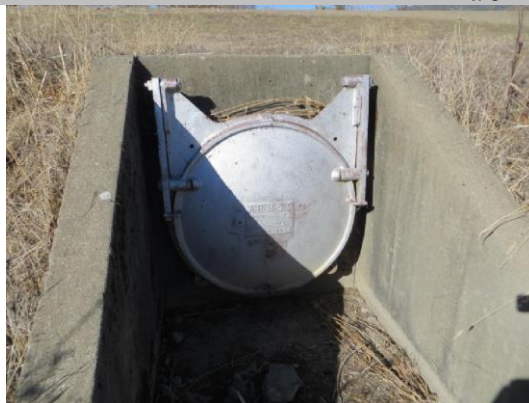
Photo 3 of 3 : UCIP_SP_2017_27004_49860.jpg

Concrete U-shaped headwall and flap gate on WS berm.

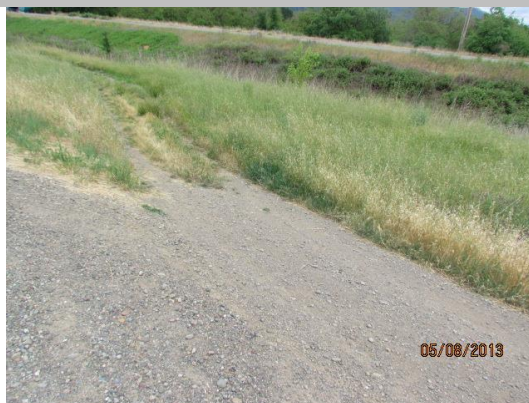
Photo 1 of 1 : SP_2017_NA0009_3_14_20170315_00008.jpg

LM Start	2.36	Rating **	M	Issue No.	14
LM End	2.36	Issue Type +	Ma	Location *	WS
Category	Earthen Levee			GPS Latitude/Longitude	
				Start	End
Item	Slope Stability			39.161153 °	39.161153 °
				-122.912740 °	-122.912740 °
DWR ID	DWR_NA0009_01_s_2013_14				
Comment Code					
S3 : Repair the levee slope damaged by vehicle traffic and prevent access where possible.					
Inspector Comment

View of the vehicle erosion along the waterside slope.

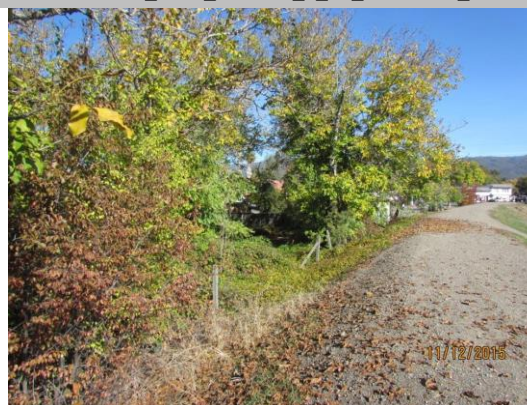
Photo 1 of 1 : SP_2017_NA0009_3_23_20170315_00013.jpg

View of the vegetation along the landside slope & toe.

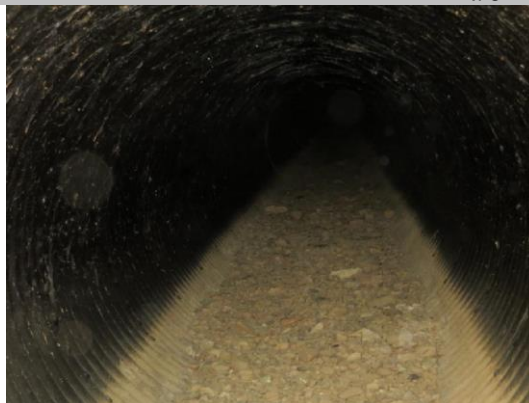
Photo 3 of 3 : UCIP_SP_2017_27066_50047.jpg

Pipe with some sediment at flowline.

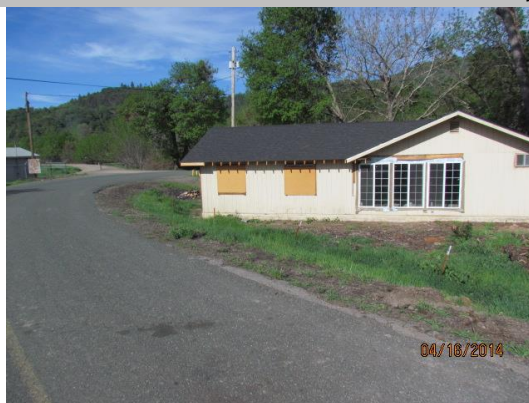
Photo 1 of 1 : SP_2017_NA0009_4_1_20170315_00001.jpg

LM Start	0.20	Rating **	U	Issue No.	1
LM End	0.20	Issue Type +	En	Location *	LS
Category	Earthen Levee			GPS Latitude/Longitude	
				Start	End
Item	Encroachments			39.187039 °	39.187039 °
				-122.908880 °	-122.908880 °
DWR ID	DWR_NA0009_02_s_2016_1				
Comment Code					
BU : Building					
Inspector Comment

View of the building on the landside toe.

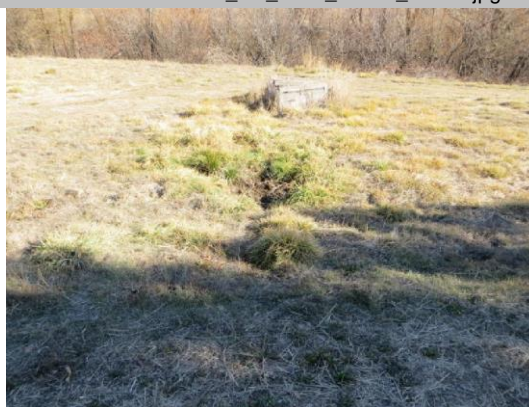
Photo 2 of 3 : UCIP_SP_2017_51435_50392.jpg

Mudpit at WS berm were pipe may be leaking.

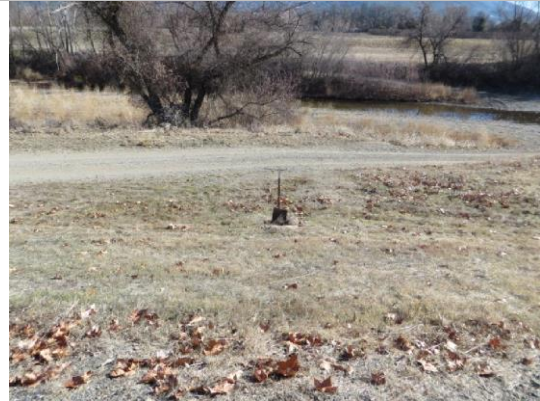
Photo 2 of 2 : UCIP_SP_2017_27606_51249.jpg

T-post at WS toe may indicate location of pipe end. Covered with soil.

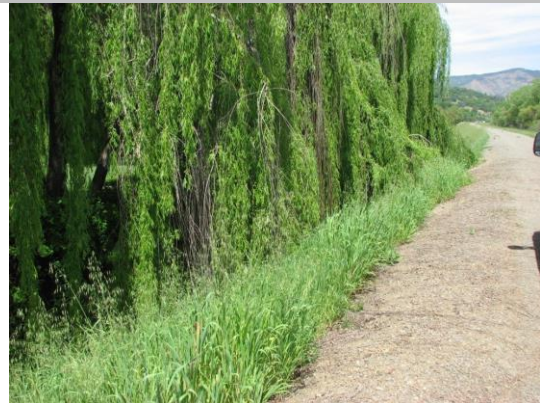
Photo 1 of 1 : SP_2017_NA0009_4_18_20170315_00009.jpg

View of the overgrown willow trees at the landside levee slope.

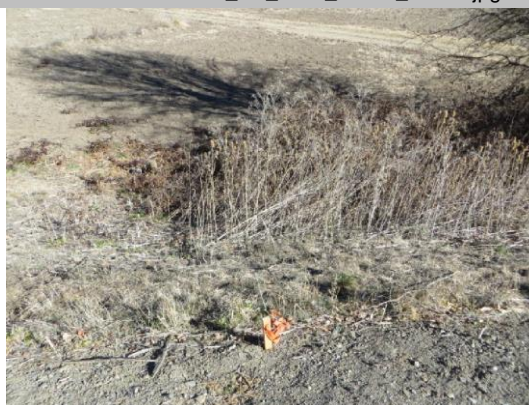
Photo 1 of 3 : UCIP_SP_2017_27863_51542.jpg

Pipe visible at LS toe covered with vegetation.

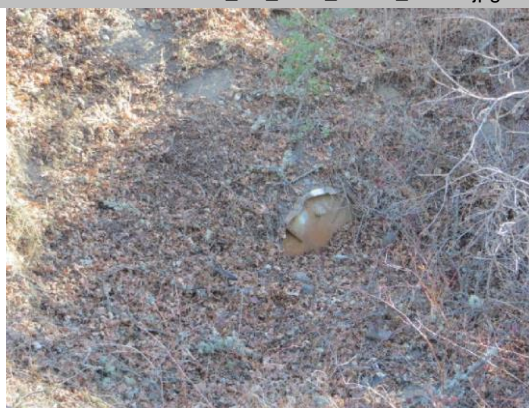
Photo 1 of 3 : UCIP_SP_2017_27893_51595.jpg

Plugged pipe visible on WS toe of roadway.

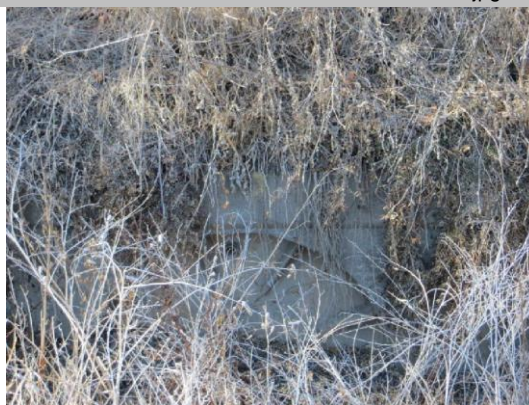
Photo 3 of 3 : UCIP_SP_2017_27893_51596.jpg

Concrete headwall and plugged pipe visible on LS toe of roadway.

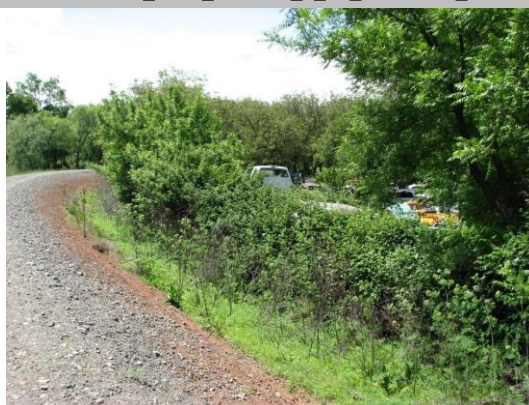
Photo 1 of 1 : SP_2017_NA0009_5_12_20170315_00003.jpg

5/2/2016: Dense bushes and vines covering fence along vehicle junk yard.
